# **Selected Images of the Effects of the October 15, 2006, Kīholo Bay-Māhukona, Hawai‘i, Earthquakes and Recovery Efforts**

Data Series 506

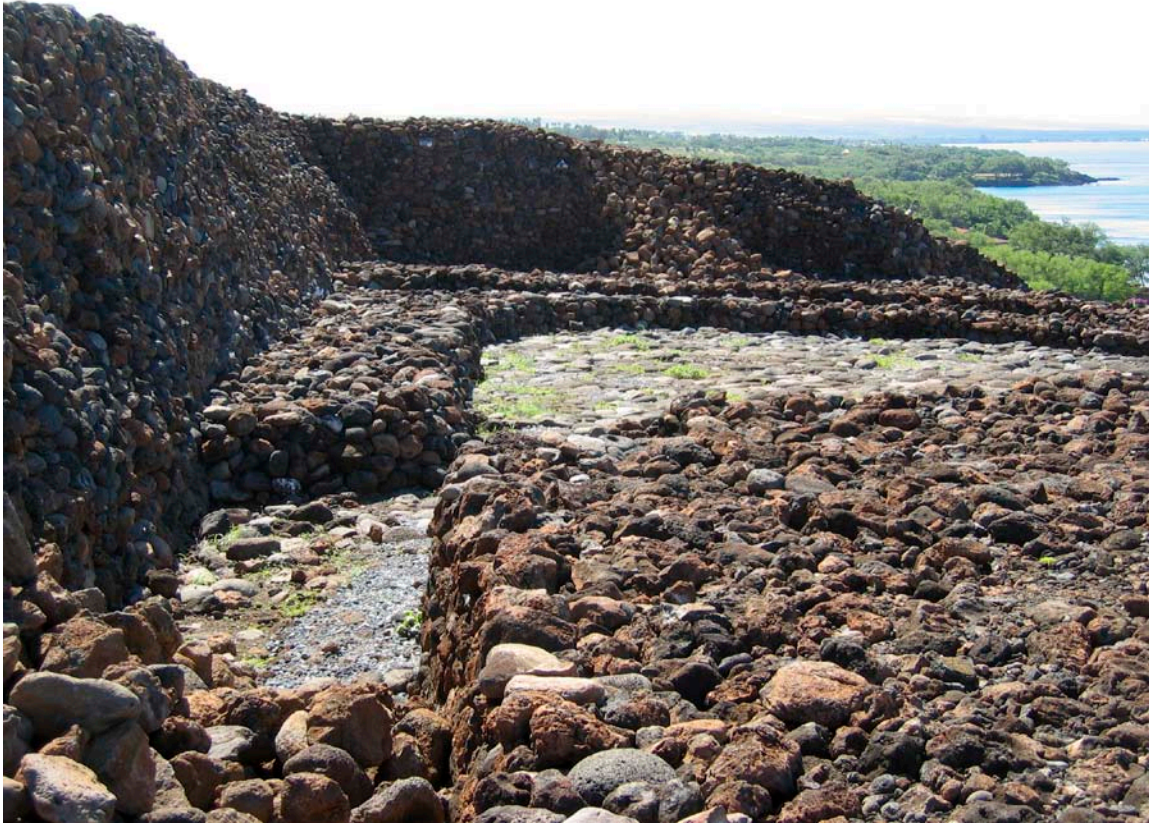
30.18. Interior view of the collapsed wall in the left foreground, vertical rippling along the east wall (left wall in the photo), and the collapsed section of the south wall (rear wall in the photo), of Pu'ukoholā Heiau (view to the south). USGS photo by M.K. Sako, 11/9/2006 (mks091).

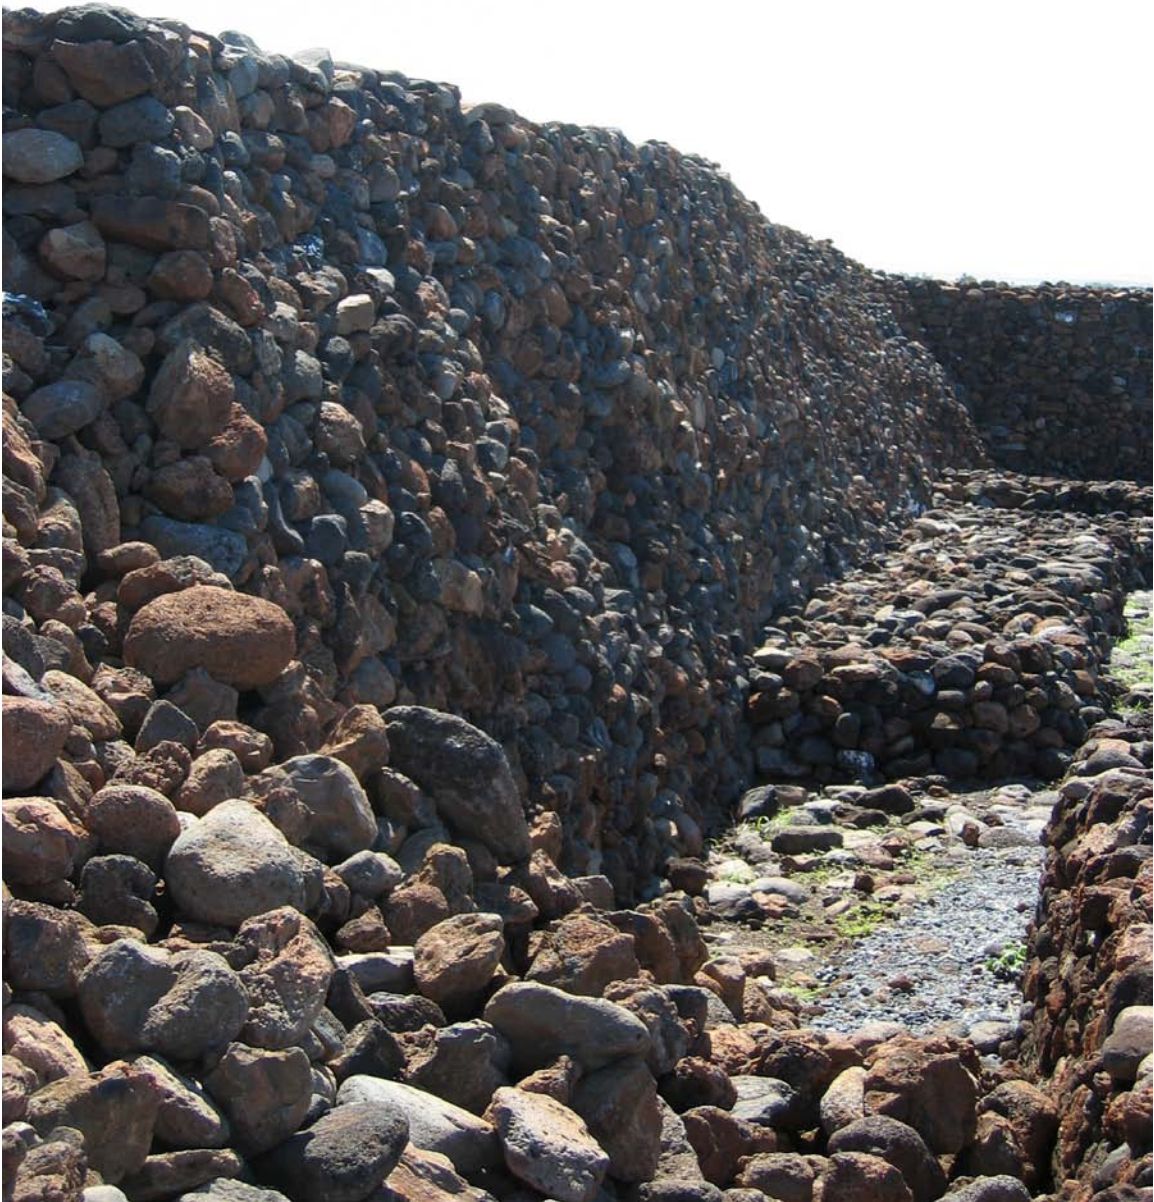
30.19. Interior view of the ripple in the east wall—and the collapsed rock wall in the foreground—of Pu'ukoholā Heiau (view to the south). USGS photo by M.K. Sako, 11/9/2006 (mks090).

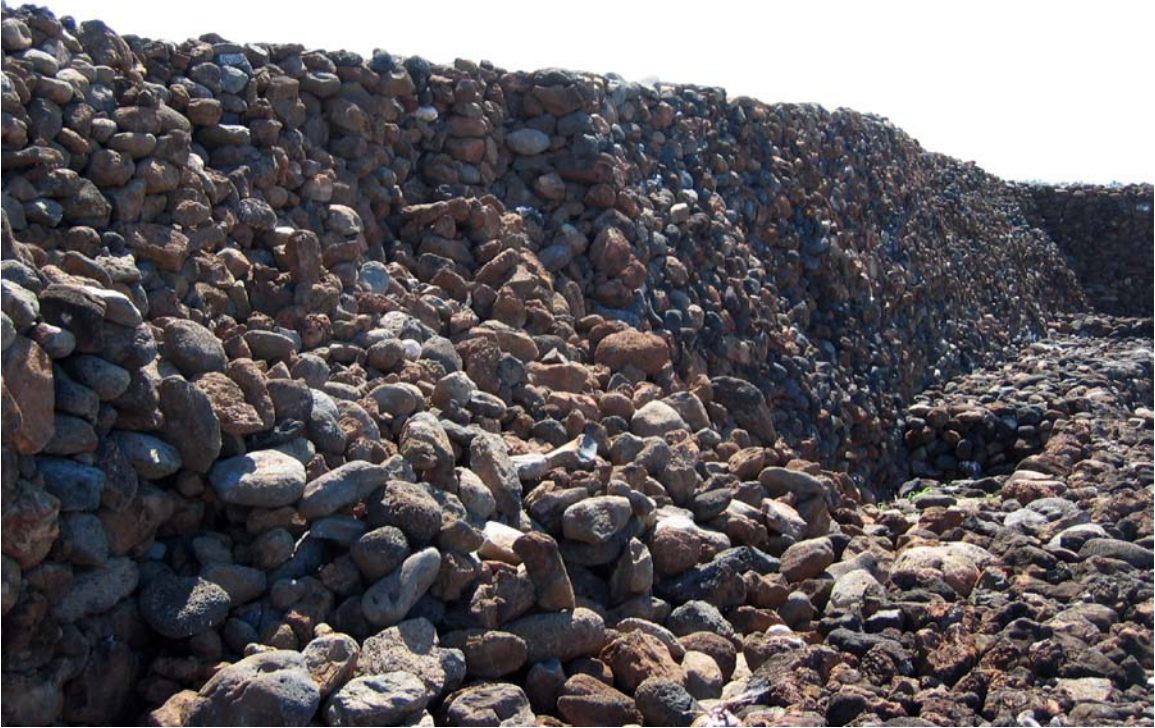
30.20. Close-up view of the collapse and ripple in the east wall of Pu'ukoholā Heiau (view to the southeast). USGS photo by M.K. Sako, 11/9/2006 (mks093).

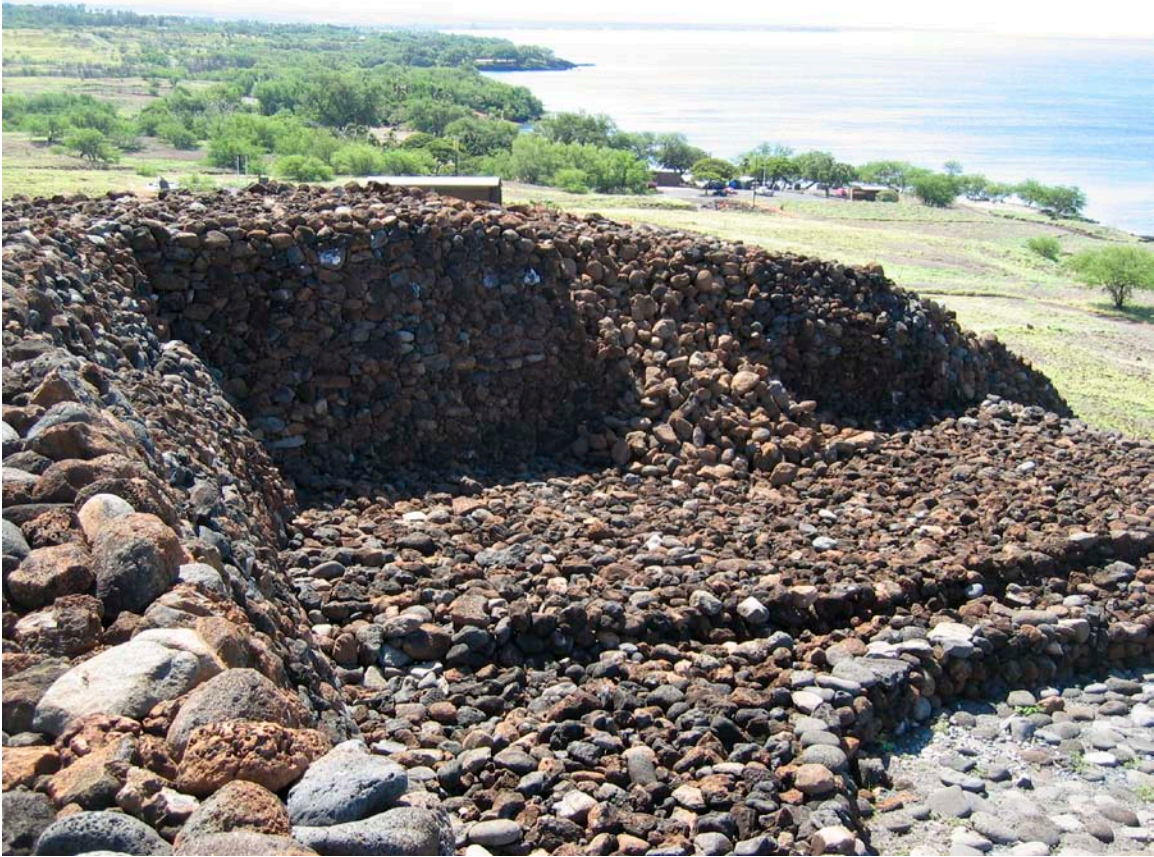
30.21. Close-up interior view of failure in the collapsed section of the south wall (center of photo) of Pu'ukoholā Heiau (view to the south-southwest). The structures and the parking area at Spencer Beach Park are visible in the (right) background. USGS photo by M.K. Sako, 11/9/2006 (mks101).

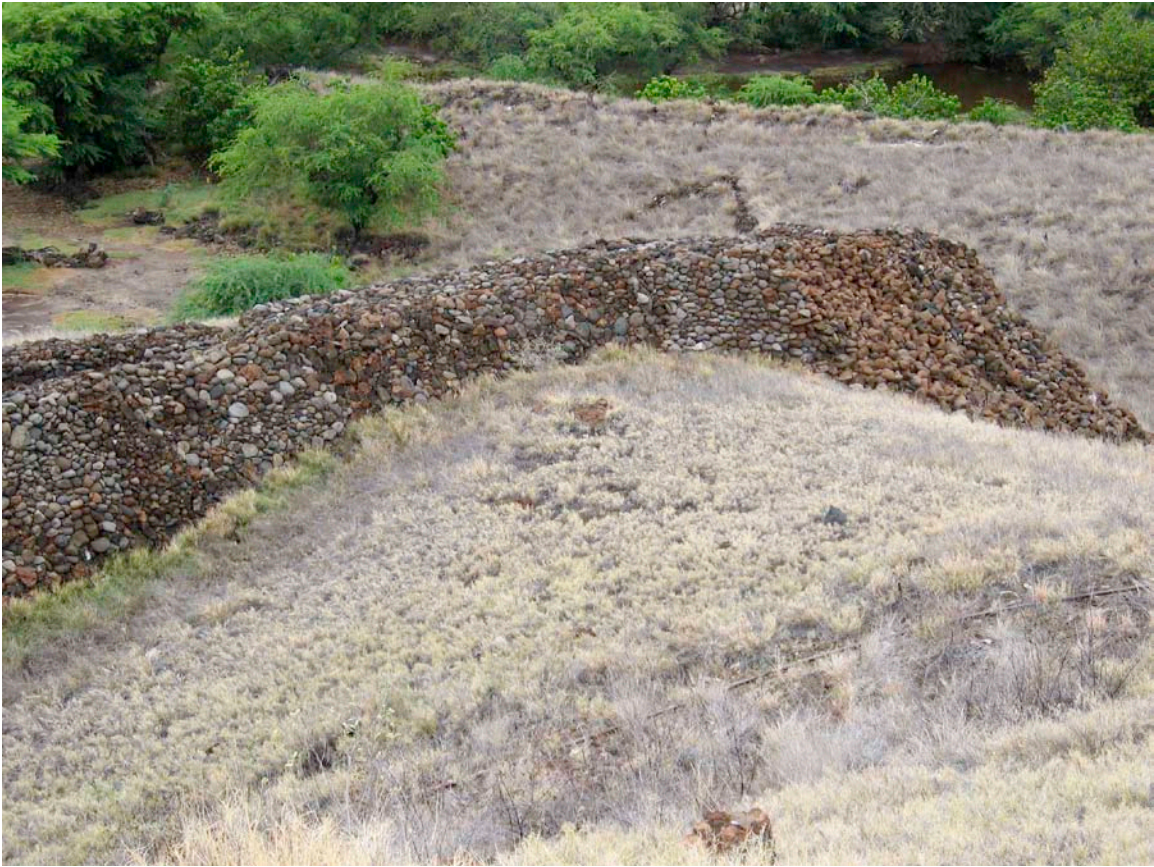
30.24. View of the northern end of the failed east-facing wall of Mailekini Heiau, showing slumping at the end of the rock wall (view to the northwest). USGS photo by M.K. Sako, 11/9/2006 (mks035).

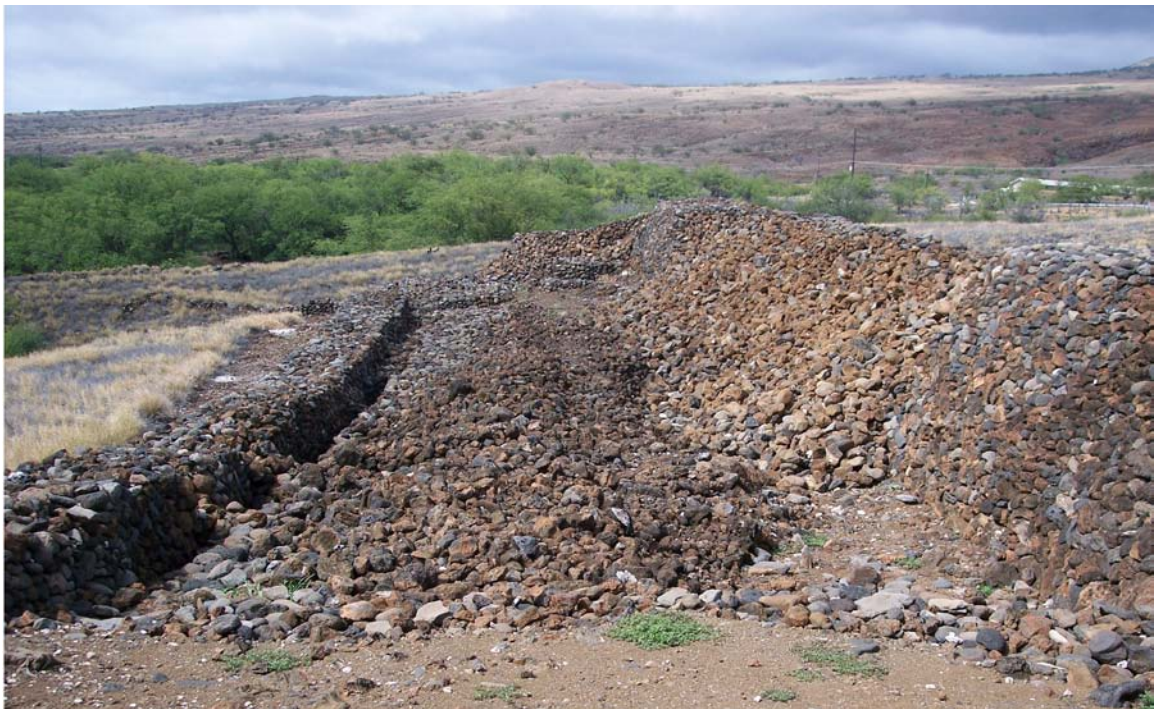
30.25. Interior view of the collapsed east wall—and minor damage to the west wall—of Mailekini Heiau (view to the north). USGS photo by T.J. Takahashi, 3/12/2007 (tjt3232).

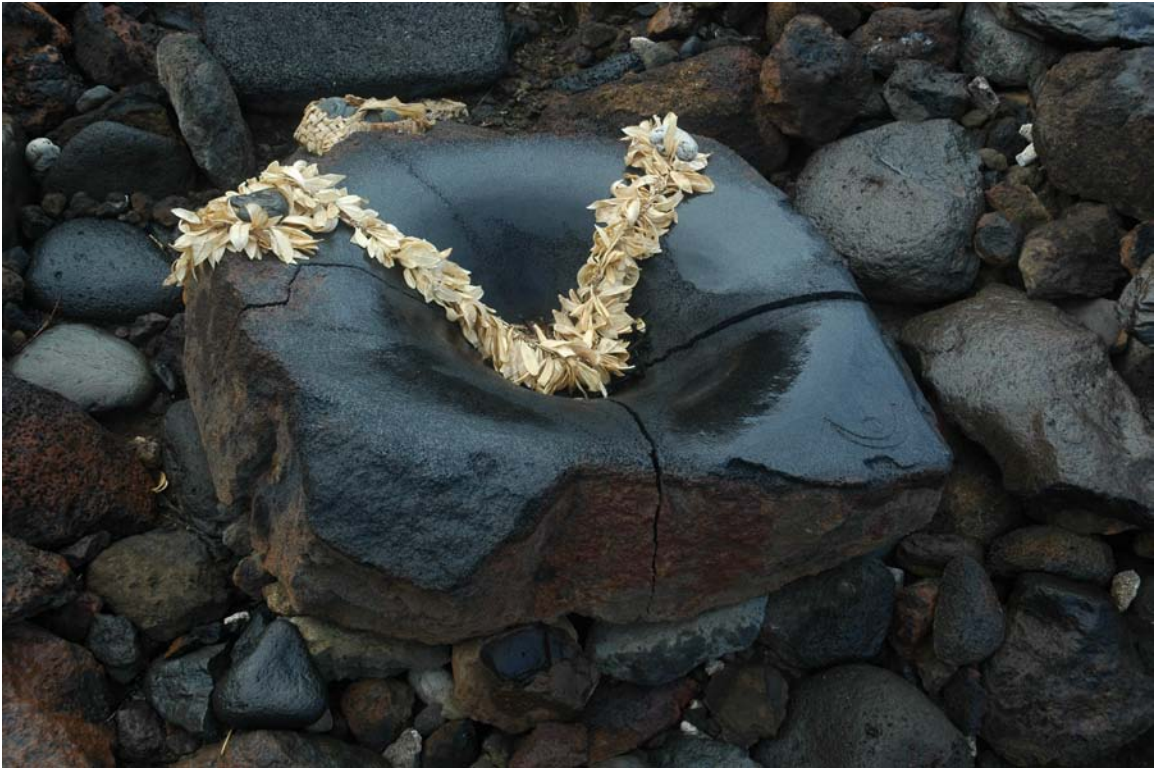
30.28. View of four-way fractures in a shaped rock vessel on a stone platform at the front of the south wall near the interior southeast corner of Mailekini Heiau after a rain (view to the south). CSAV photo by D.A. Whilldin, 10/20/2006 (daw021).

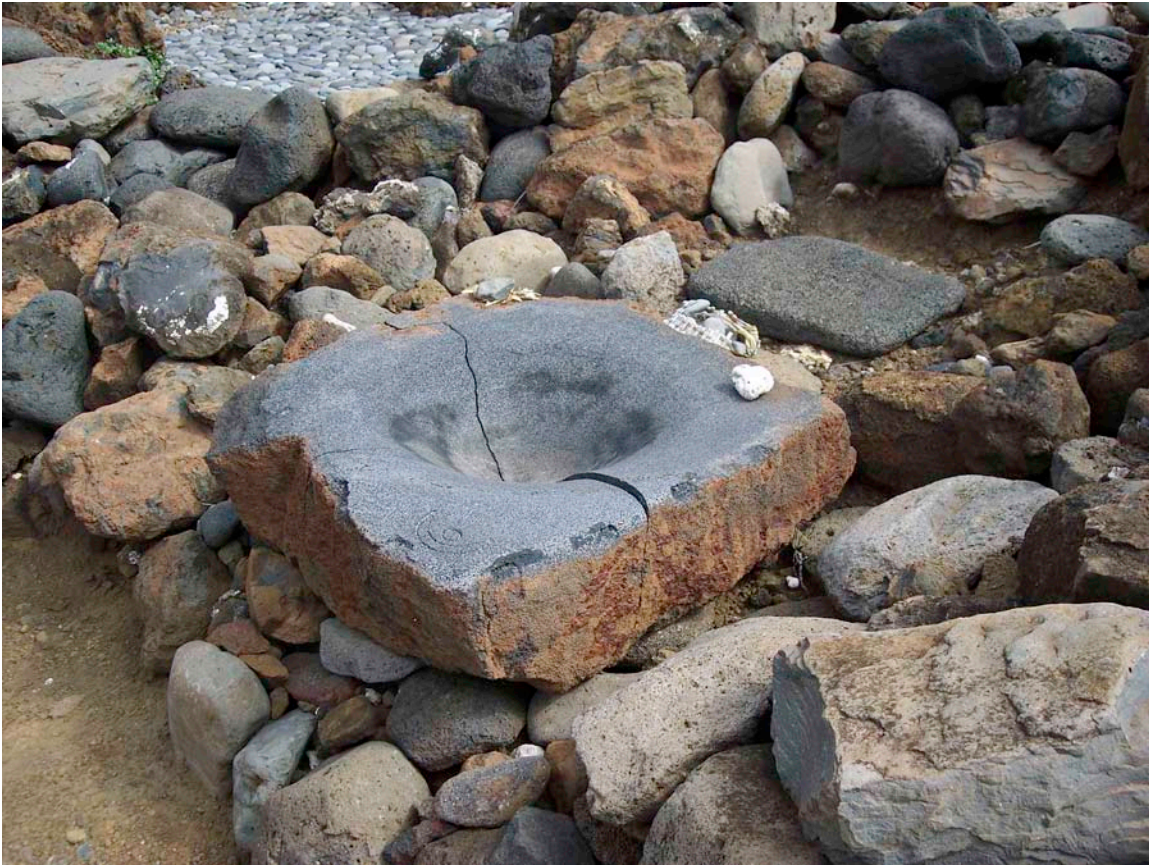
30.29. View, when dry, of fractures in the same shaped-rock vessel (see image 30.28 (daw021); (view to the southeast). USGS photo by T.J. Takahashi, 3/12/2007 (tjt3228).

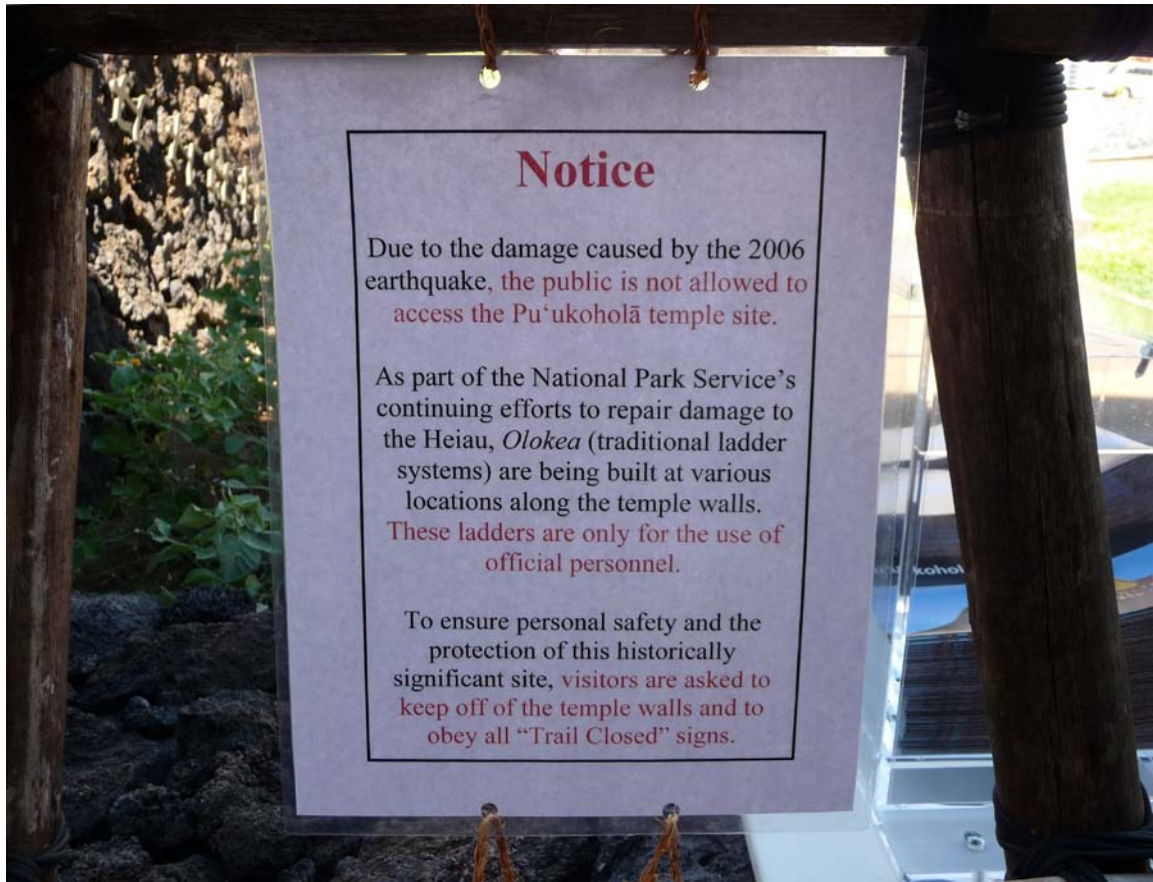
30.30. View of closure notice at Pu‘ukoholā Heiau while it undergoes repairs (view to the north). USGS photo by N.A. Ikeda, 7/11/2008 (nai629).

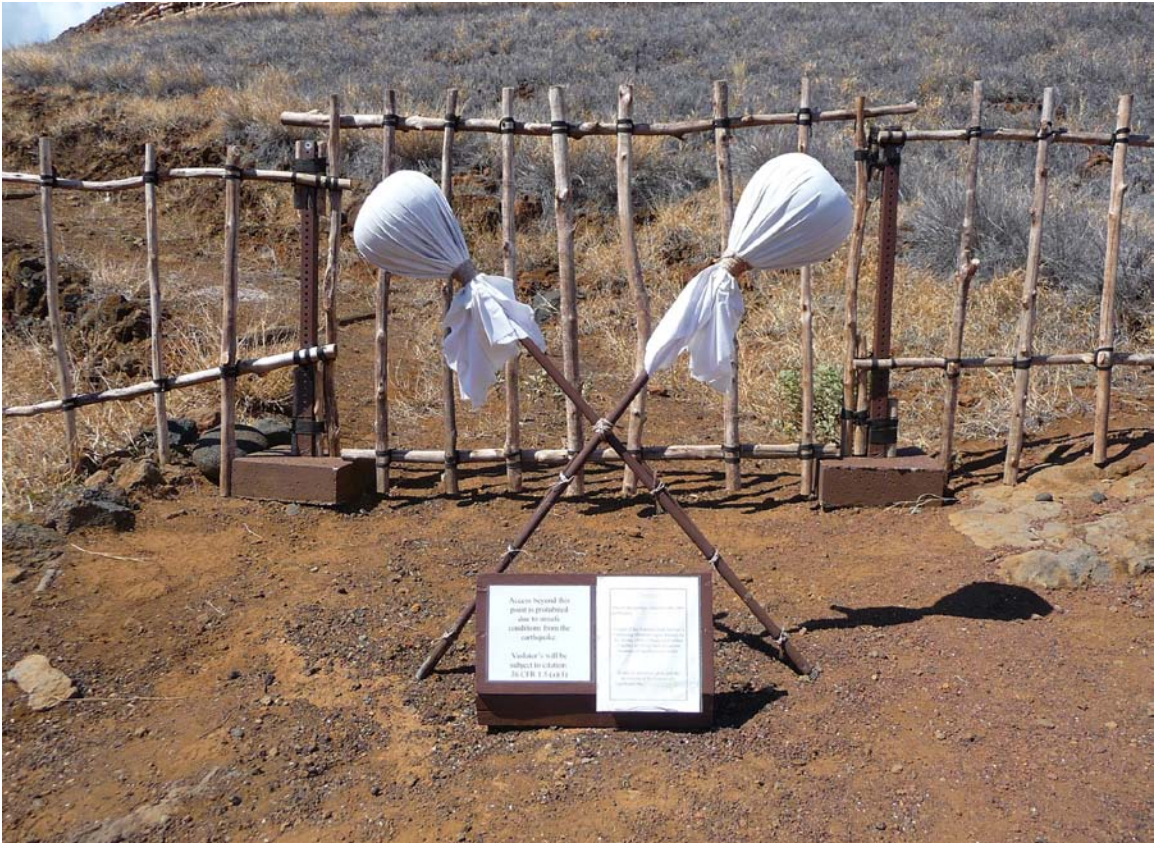
30.33. View of a closure sign, symbolic crossed standards, and gate barring entry to the area under restoration (view to the northeast). USGS photo by N.A. Ikeda, 7/11/2008 (nai638).

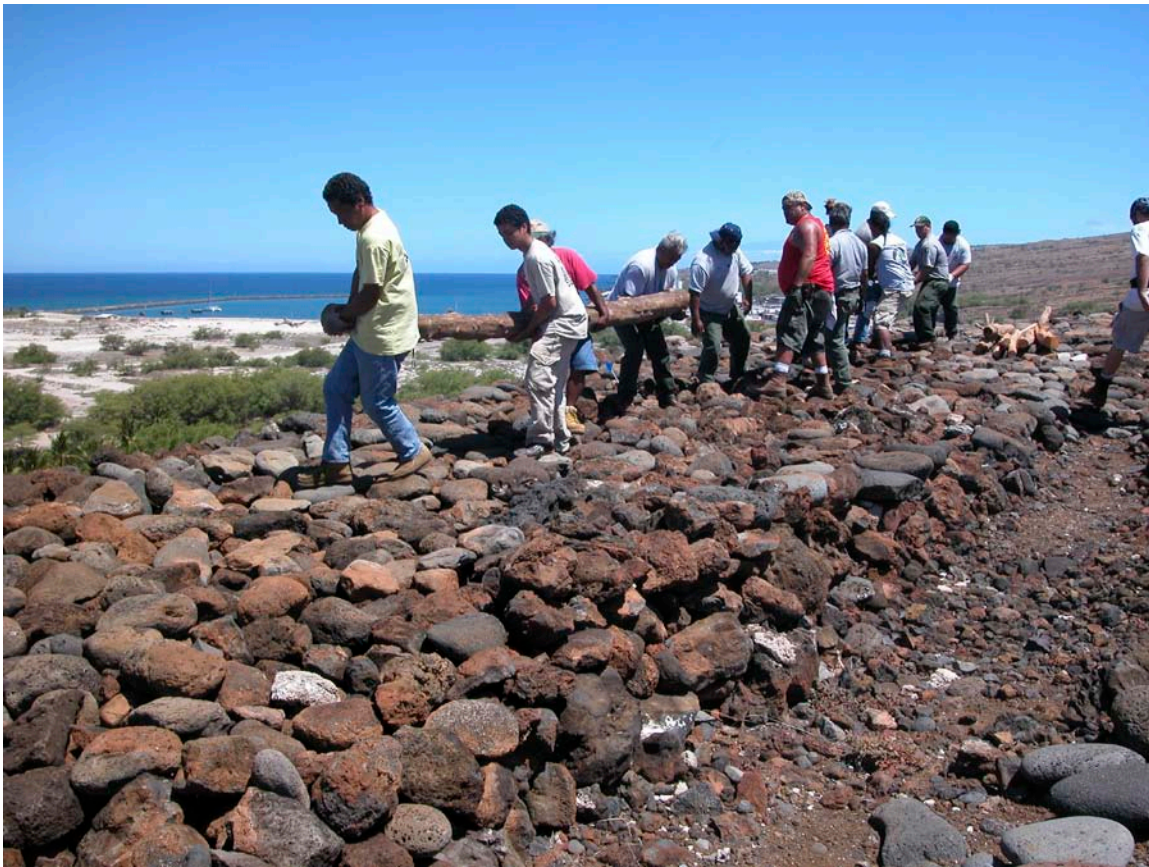
30.34. View of work crew members carrying freshly cut ironwood logs to the west terrace of Pu'ukoholā Heiau, where they will be laid out for drying near the restoration work. After drying, the logs are light enough to be carried by a single person (view to the northwest). NPS photo by A.M. Johnson, 6/10/2008 (amj003).

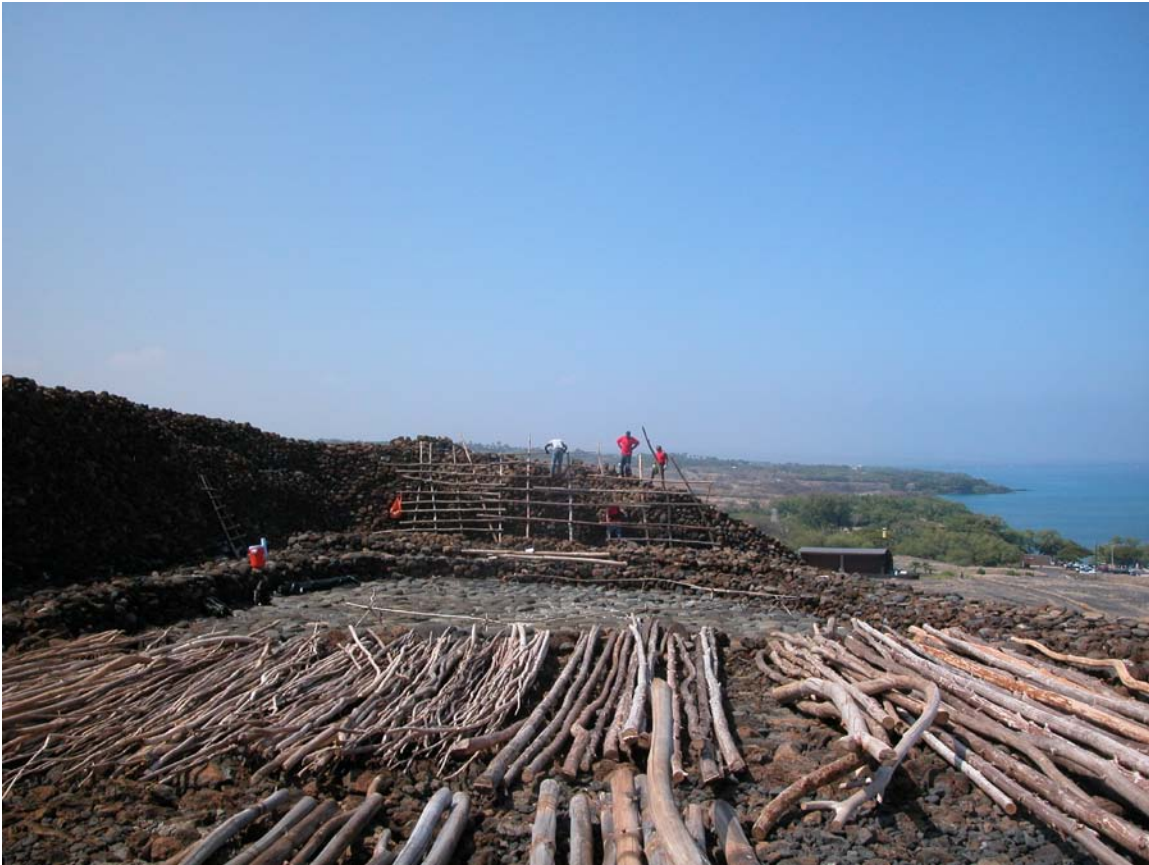
30.35. View of work crew members erecting ‘oloke‘a (scaffolding) to repair the south wall of Pu‘ukoholā Heiau. Dried logs and branches for constructing ladders are sorted and carefully laid out (foreground) (view to the south). NPS photo by A.M. Johnson, 6/30/2008 (amj006).

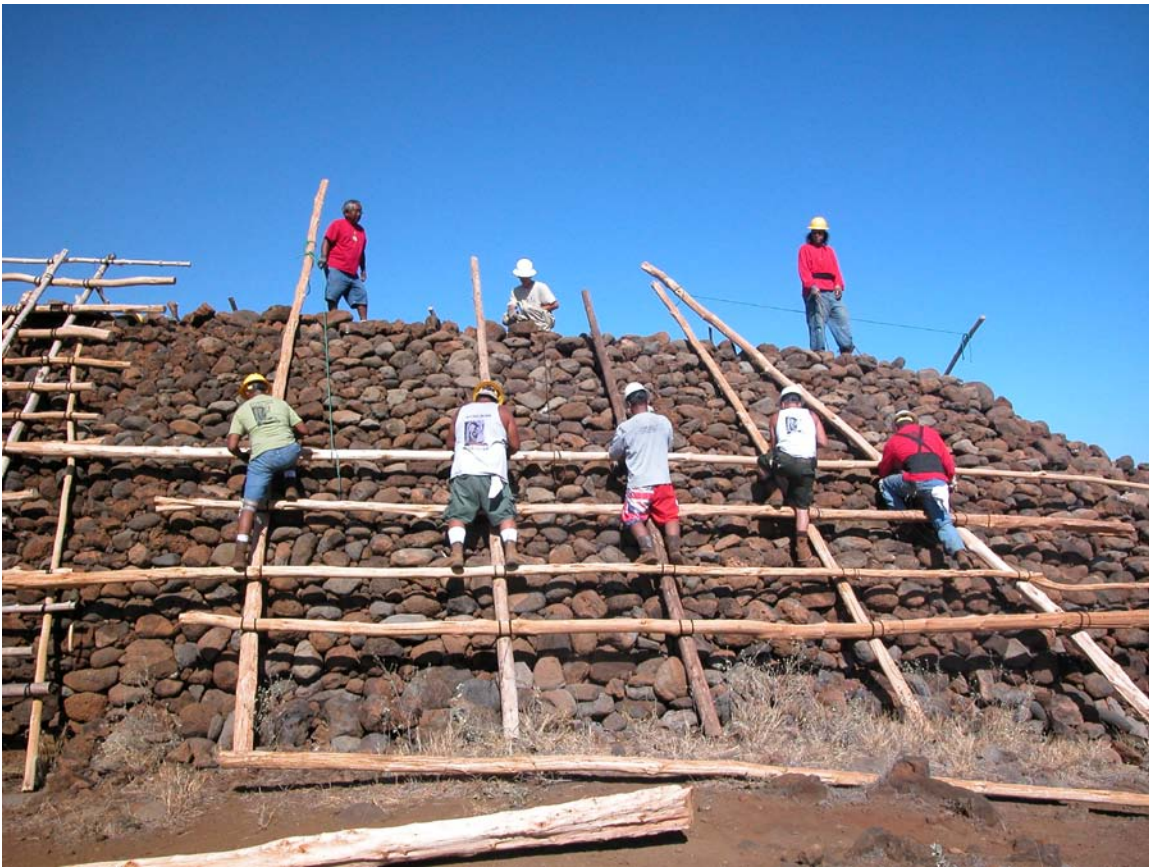
30.36. View of crew members working on cross-members of ‘oloke‘a, using traditional methods of ladder construction, to repair the east wall of Pu‘ukoholā Heiau (view to the west). NPS photo by A.M. Johnson, 6/30/2008 (amj039).

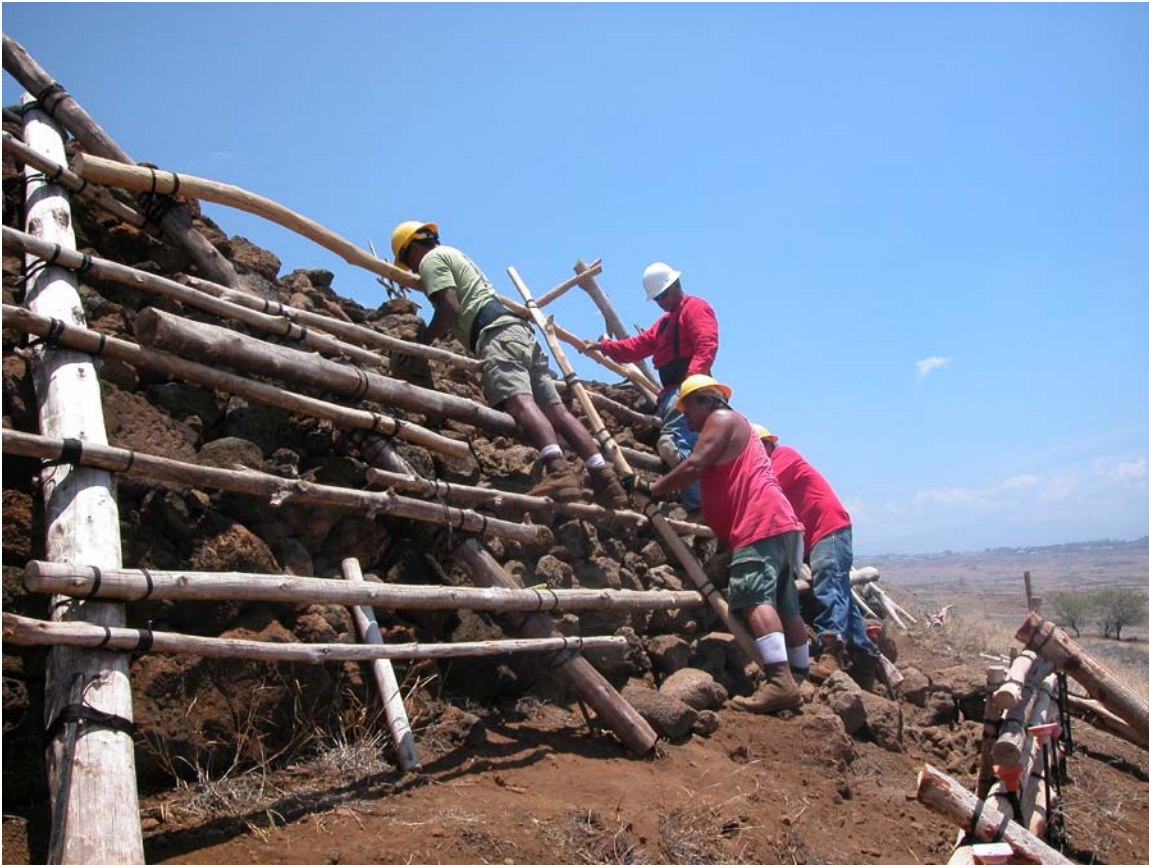
30.37. View of crew members working on light, sun-dried ladders to realign the west wall of Pu'ukoholā Heiau (view is to the southeast). NPS photo by A.M. Johnson, 6/11/2008 (amj055).

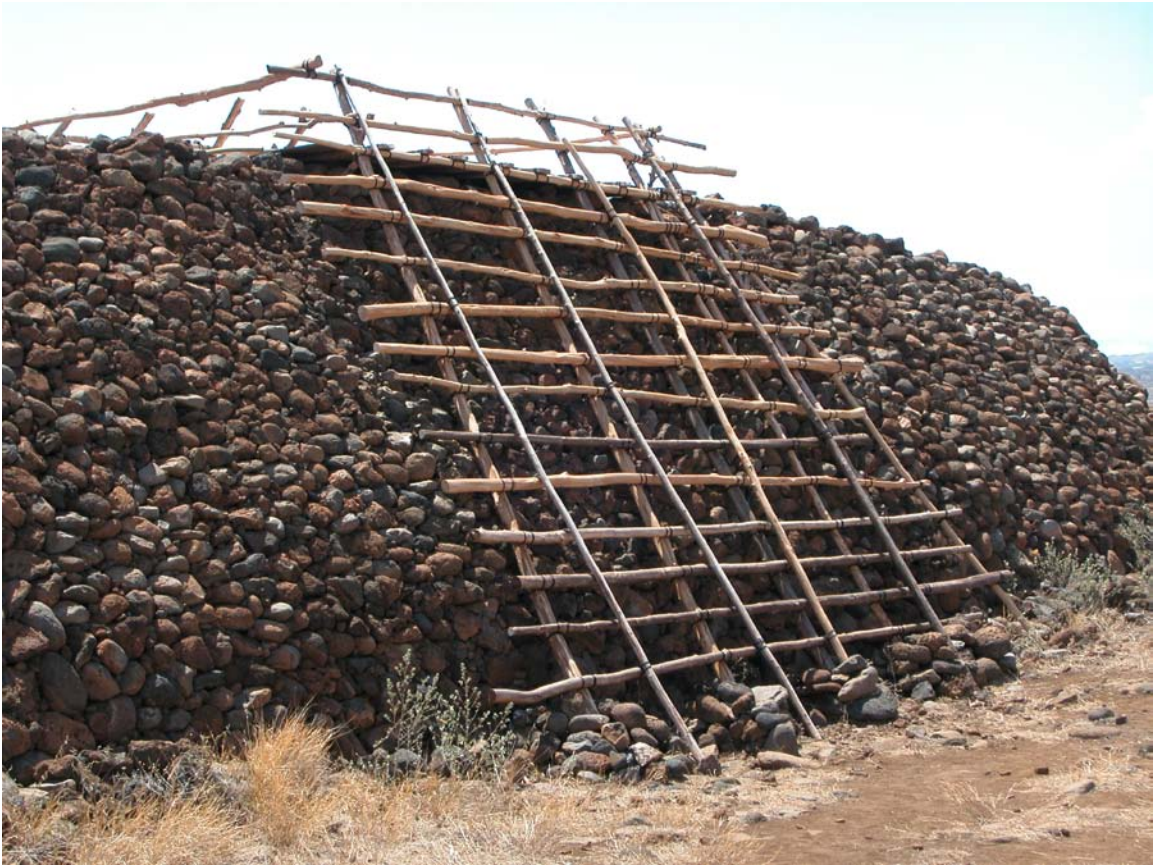
30.38. View of a completed ladder resting against the east wall of Pu'ukoholā Heiau (view to the northwest). NPS photo by A.M. Johnson, 6/11/2008 (amj035).

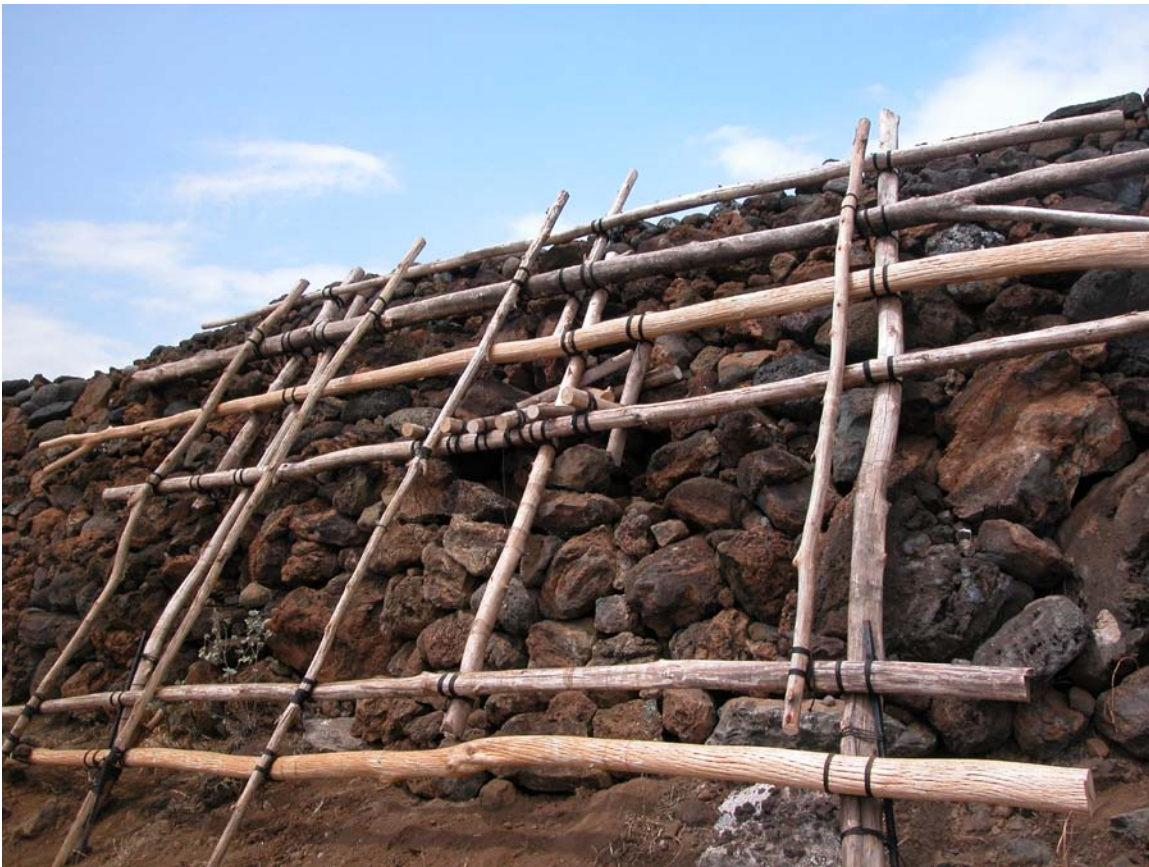
30.39. Close-up view of the traditional method of ladder construction. A ladder rests on the west terrace of Pu'ukoholā Heiau (view to the east-northeast). NPS photo by A.M. Johnson, 6/11/2008 (amj036).

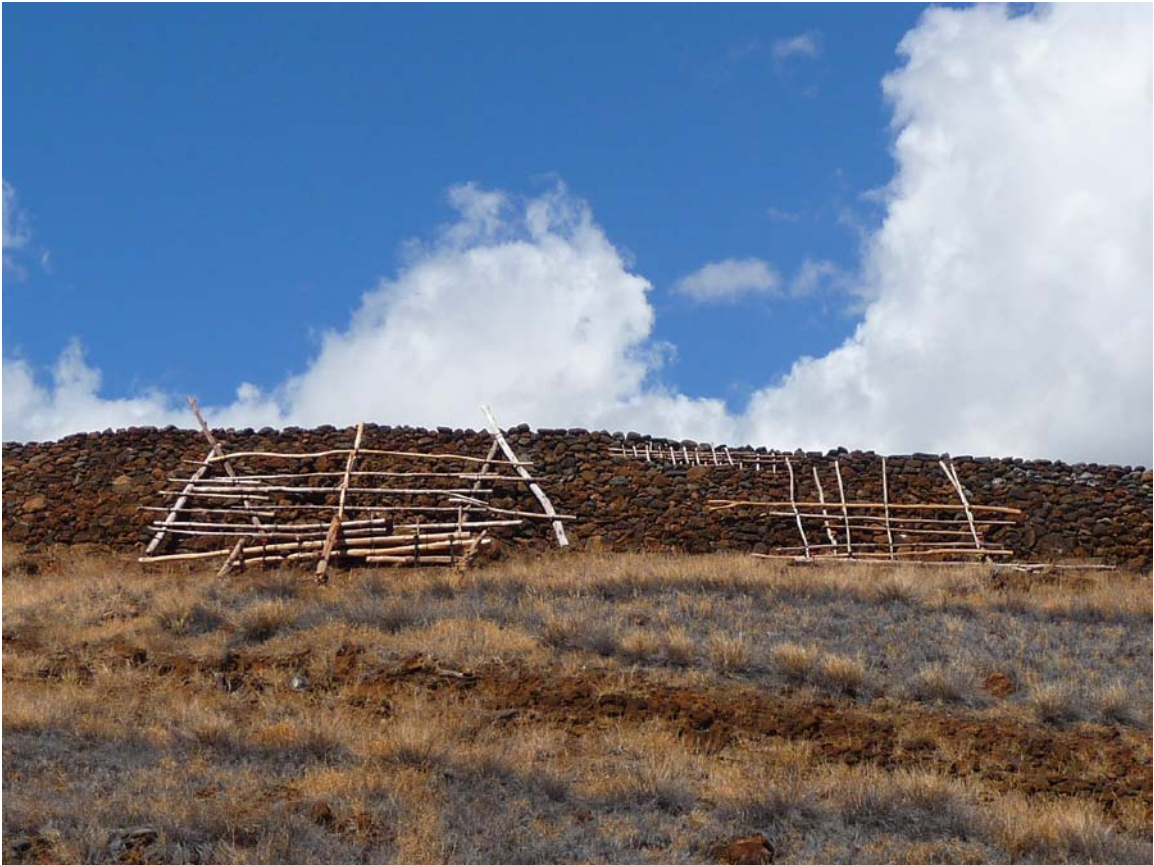
30.40. View of completed and partially completed ladders leaning against the west wall of Pu'ukoholā Heiau (view to the east). USGS photo by N.A. Ikeda, 7/11/2008 (nai635).

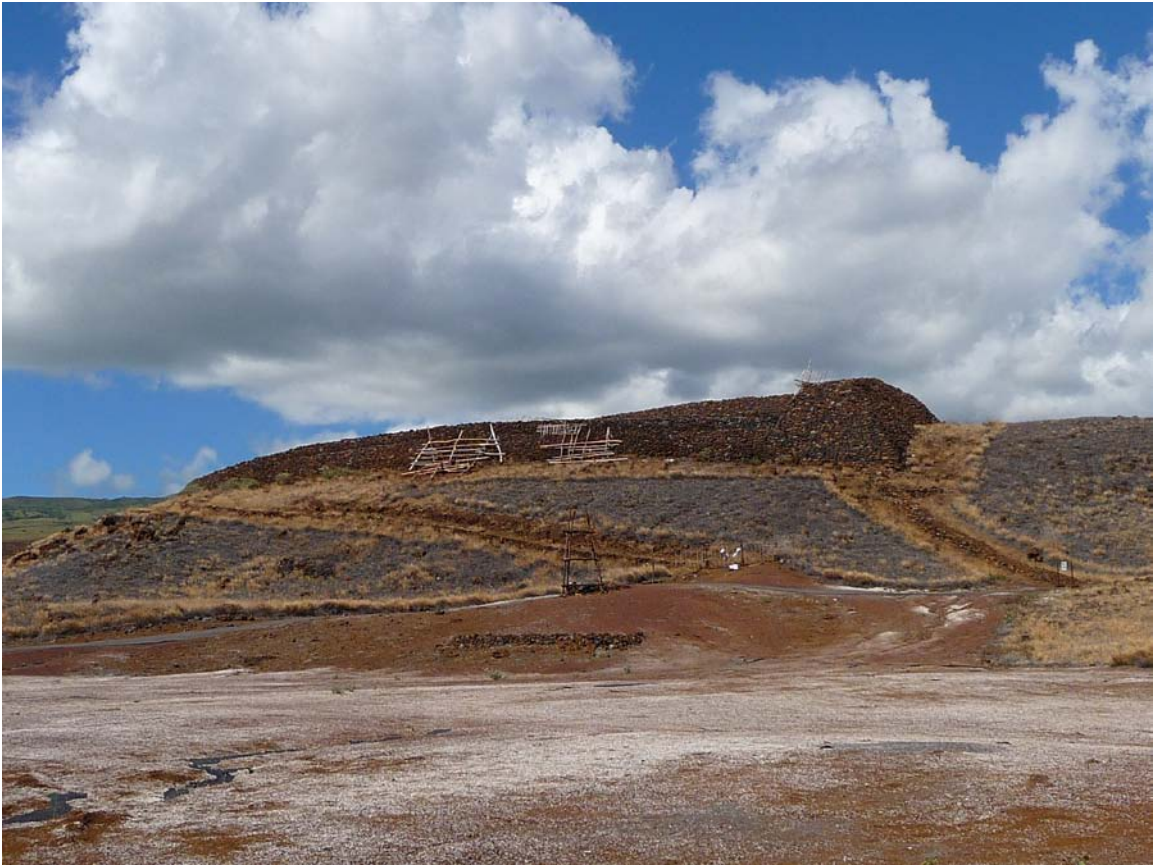
30.41. *Overview image*: Ladders lean against the west wall of Pu'ukoholā Heiau (view to the east-northeast). USGS photo by N.A. Ikeda, 7/11/2008 (nai644).

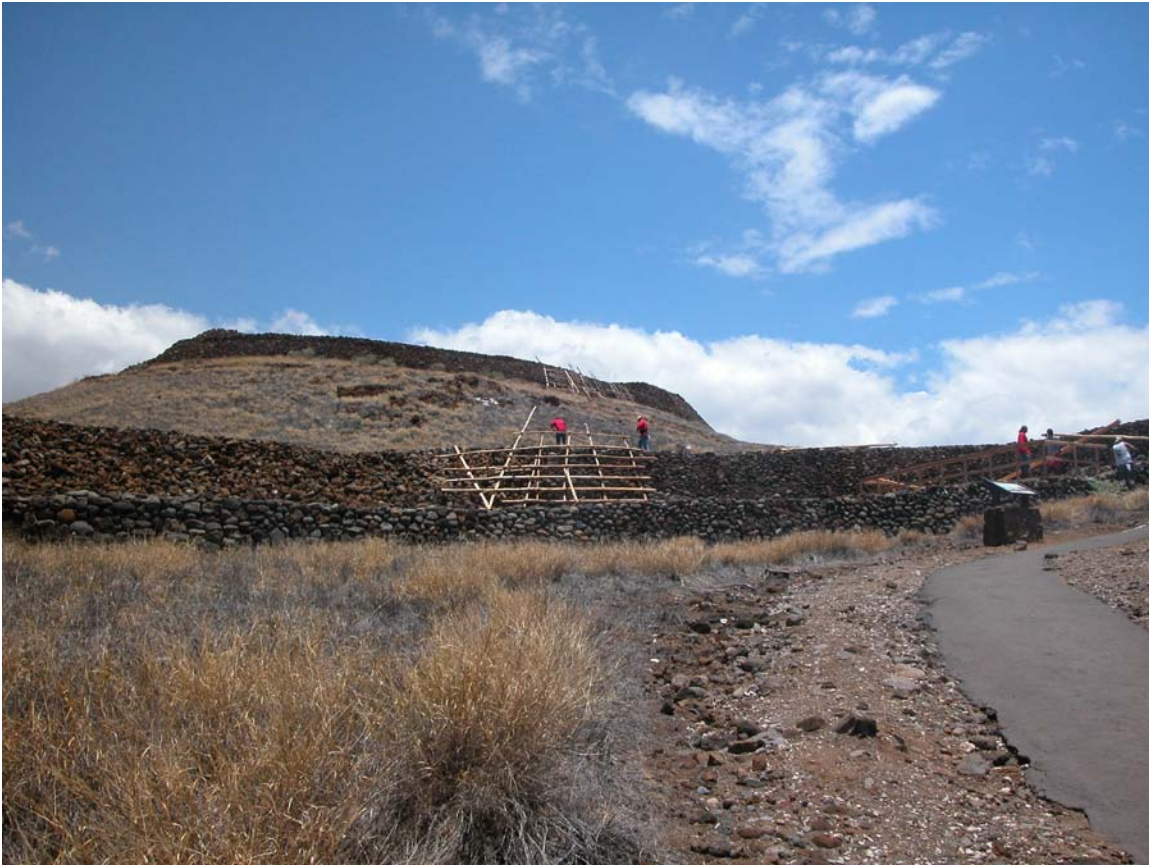
30.42. View of crew members repairing Mailekini Heiau (view to the east-southeast).  
NPS photo by A.M. Johnson, 6/11/2008 (amj045).

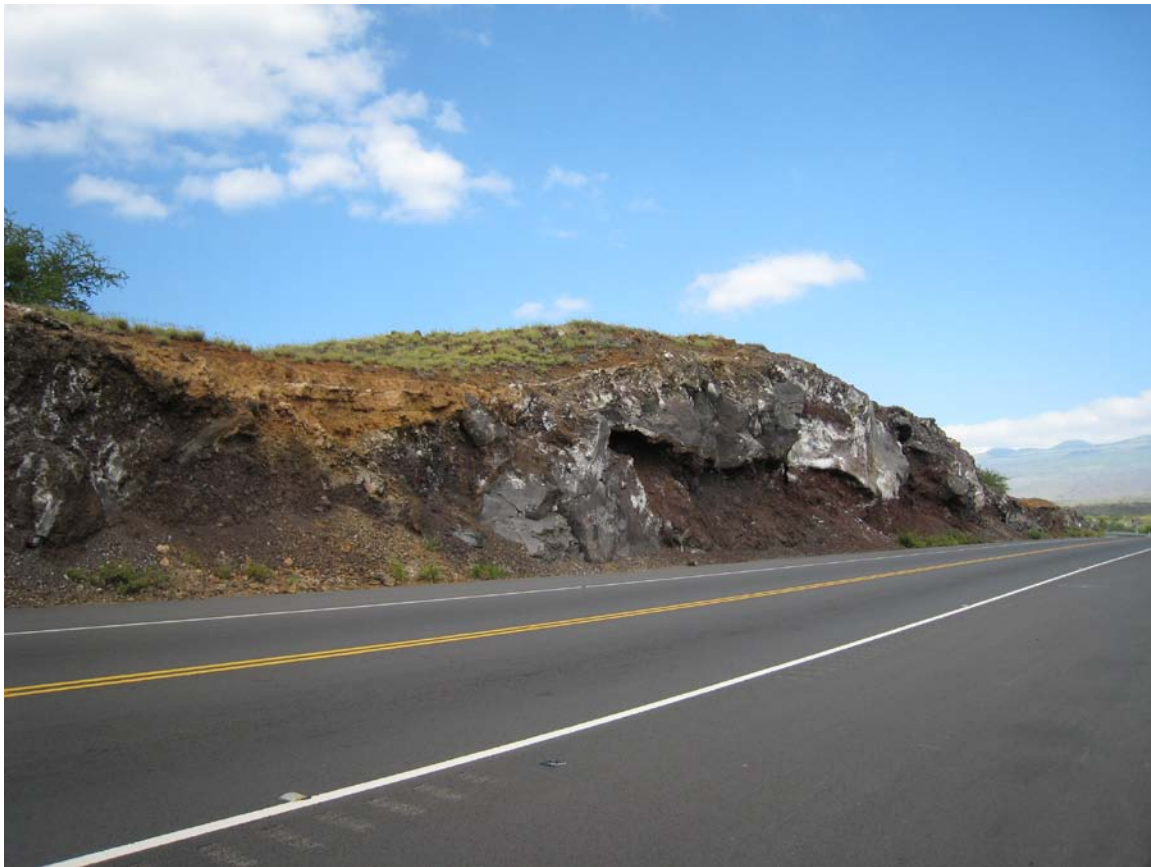
31.1. *Overview image:* Road cut, approximately 2.4 km (~1.5 mi) past the Puakō turnoff, shows the dense core of an ‘a‘ā flow, topped with a soil layer (view to the north). USGS photo by T.J. Takahashi, 1/24/2009 (tjt1122).
